Monitoring Results from the
First Boston Harbor Navigation
Improvement Project Confined
Aquatic Disposal Cell

Disposal Area Monitoring System DAMOS

Contribution 124
January 1999

Report No.
SAIC 443

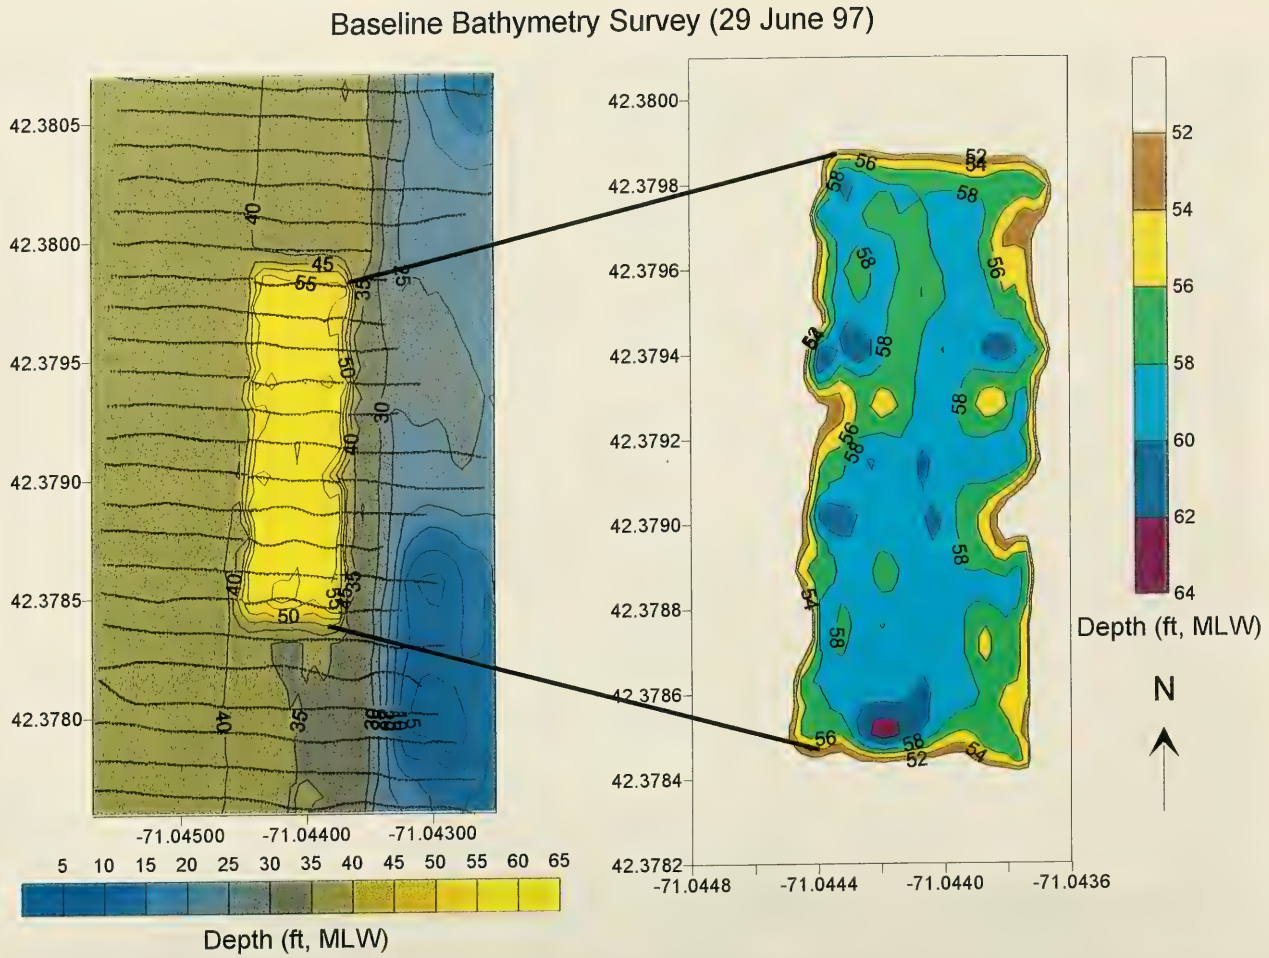
Figure 1-4. Bathymetry of cell area following excavation, prior to material disposal (NAD83).

The predisposal baseline bathymetric survey showed ambient water depths ranging from 5 to 40 ft in the area around where the cell was excavated (Figure 1-4). Water depths in the cell itself prior to disposal ranged from 56-64 ft MLW. The cell walls were fairly irregular, showing scalloping along the edges remnant from the clamshell excavation. The deepest part of the cell was in the southwestern corner, and there were several topographically higher areas along the edges and in the center of the cell.

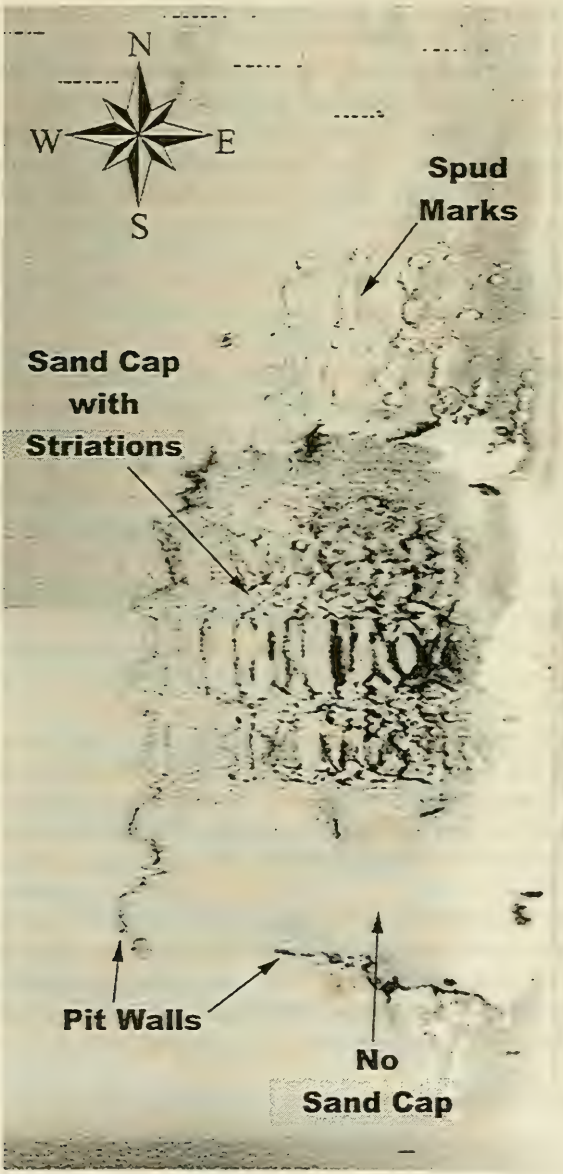
Figure 3-1. Side-scan sonar image of surface of cell.

The side-scan sonar data over the cell area showed distinct acoustic regions of the cell (Figure 3-1). The southern end of the cell consisted of a uniform low reflectance area interpreted as a flat surface. Strong backscatter from the central and northern portions of the cell indicated a harder bottom, and a rough, uneven topography. Throughout the central portion of the cell, clamshell bucket markings were noted clearly, with dark shadows indicating strong changes in topography that we termed artificial "sand waves" for further discussion. Two of the three dredge cuts (NAE 1997), aligned east-west, showed individual ridges caused by clamshell bucket passes. The third most northern cut was partially obscured because of the sand that was disposed in the northern part of the cell after dredging (Section 1.2). Spud marks from the dredge were noted along the northern edge.

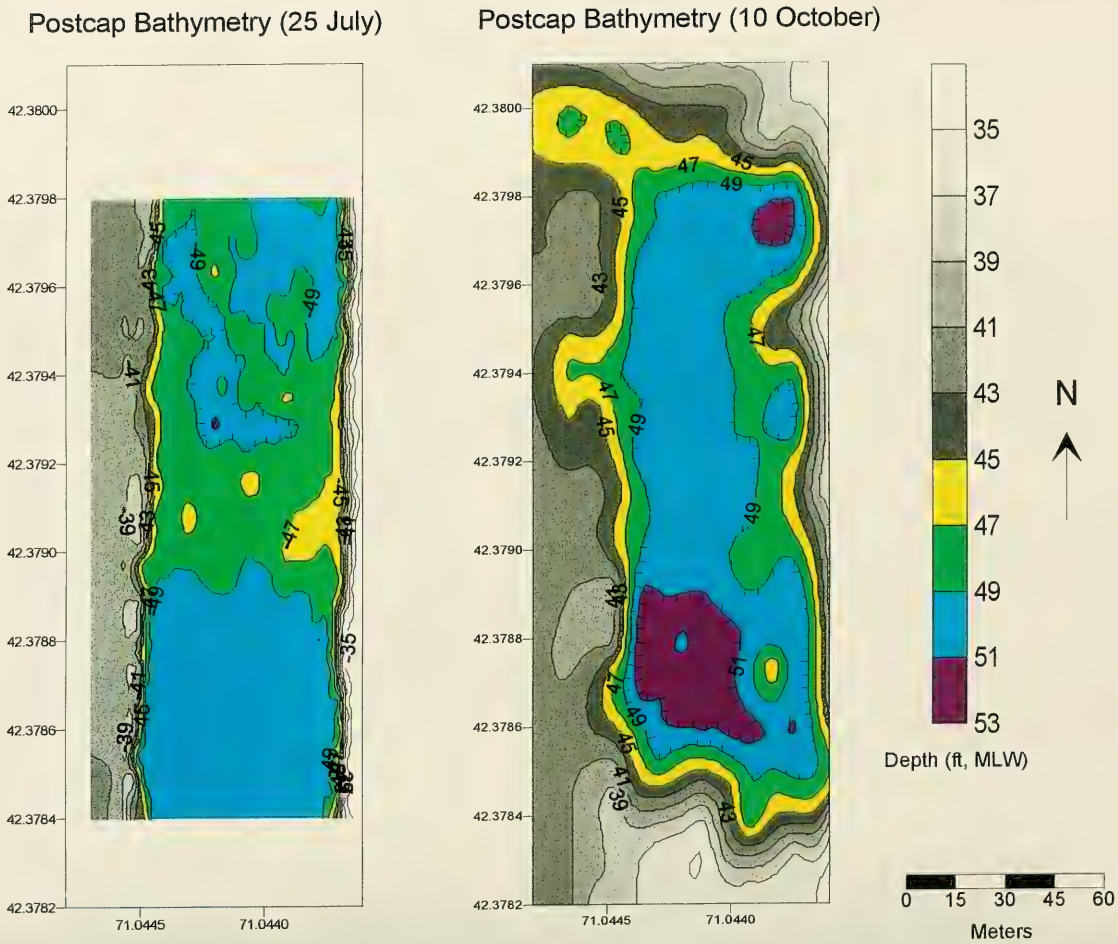
Figure 3-2. Bathymetry of cell area after completion of capping in a) July (Weeks Marine); and b) October 1997 (SAIC); view towards the southern end of the cell.

The postcap survey conducted after completion of the project (Figure 3-2a) showed steep, almost vertical, western and eastern cell walls (lanes were not extended to the southern and northern ends of the cell). Depths ranged between 46-50 ft, with the shallowest depths in the center of the cell consistent with the areas of dredge-induced sand waves shown by the side-scan sonar data. The southern end of the cell was relatively flat (49-50 ft). The average thicknesses of dredged and cap material, therefore, was approximately 10 ft, with a range of thicknesses over the variable topography of the cell floor of approximately 6-14 ft.

The survey conducted in October by SAIC resulted in somewhat less steep cell walls, and a more irregular topography on the floor of the cell (Figure 3-2b). Overall, the bottom of the cell appeared to increase in depth by 1-4 ft (i.e., the bottom of the cell was deeper) over most of the cell during the period between the July and October postcap surveys. Some areas north and south of the sandy peaks from the final postdisposal survey appeared to remain relatively constant between the two surveys (49-51 ft, blue areas). Considering the approximate 1-2 ft of error between the two surveys, the maximum consolidation that could be confidently estimated was at least 2 ft in the far southwestern corner of the cell and in the center of the cell below the thick sandy peaks. Conservatively, this resulted in an overall consolidation of 10-20% since the final postcap survey, concentrated in the dredged material as sand is relatively incompressible. Including the consolidation prior to capping, the total consolidation of the dredged material ranged from 20-40% during the four months past the initial capping. This value was

An anomalous topographic peak in the southeastern corner of the cell was noted several feet higher than was measured in the previous postcap survey in July (Figure 3-2). The location of the peak was consistent with the hard reflector seen in the side-scan sonar data, and was also seen in the subbottom results (Section 3.4). As discussed below, this deposit may be material that ended up overlying the uncapped dredged material, possibly a remnant of material fallen from the cell wall.

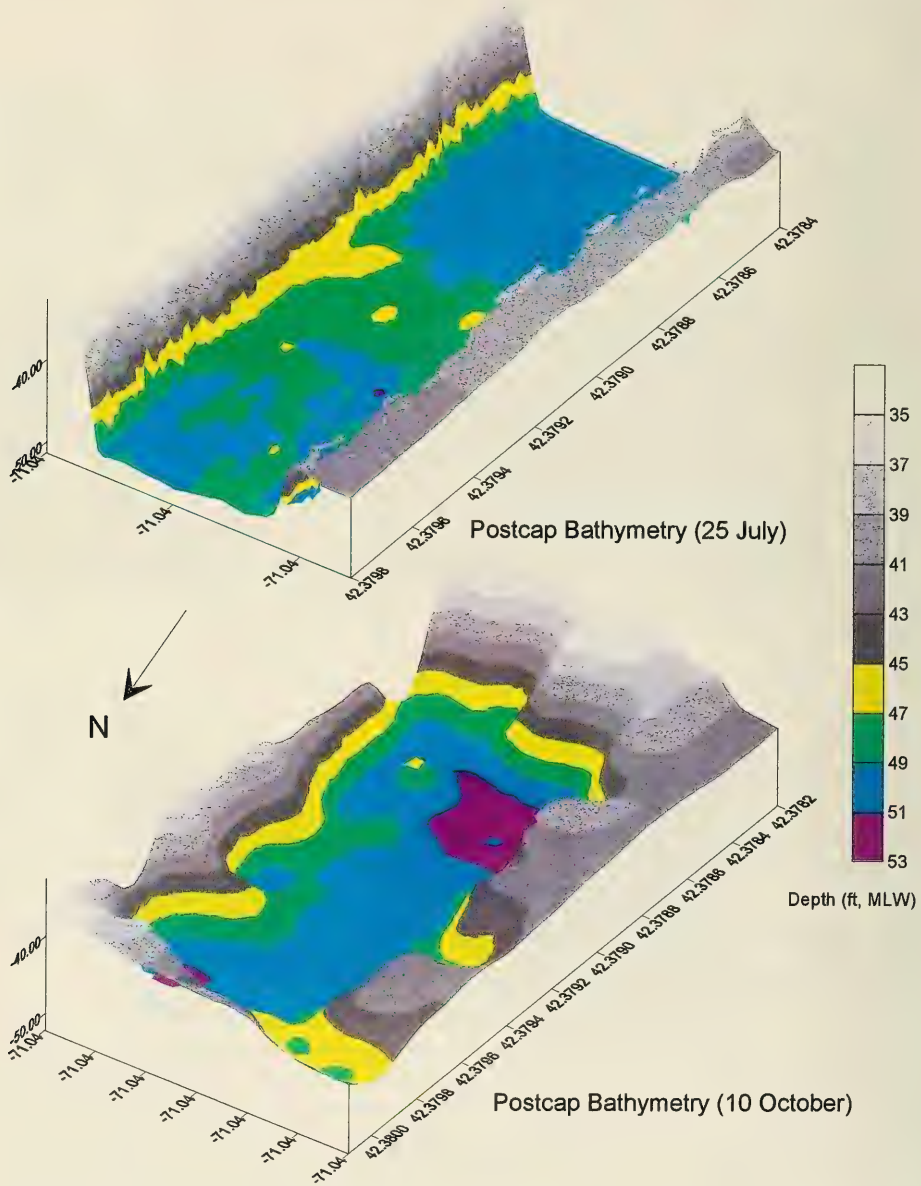
Figure 3-3. 3D view of postcap cell bathymetry in a) July (Weeks Marine); and b) October 1997 (SAIC); view towards the southern end of the cell.

Viewing the data from a three dimensional perspective, the bathymetric data suggested that the slope of the cell walls had become less steep over the 10 weeks between surveys (Figure 3-3). Several areas appeared to show slumping of the wall itself (note far northwestern corner). Sequential side-scan sonar datasets collected during the disposal phase also suggested the outline of the cell wall changed through time (ENSR 1997a). Because the clamshell dredge that was used to create the cell left a sawtooth pattern along the cell walls, it is likely that the dredging process weakened parts of the wall and material sloughed or calved from the walls into the cell. Because Boston Blue Clay is relatively firm (e.g., CDM 1991), this process will likely not continue indefinitely, but until a stable slope for BBC material has been reached. The force of ship propellers along the piers may have also tended to weaken the unsupported walls, especially along the eastern wall of the cell.

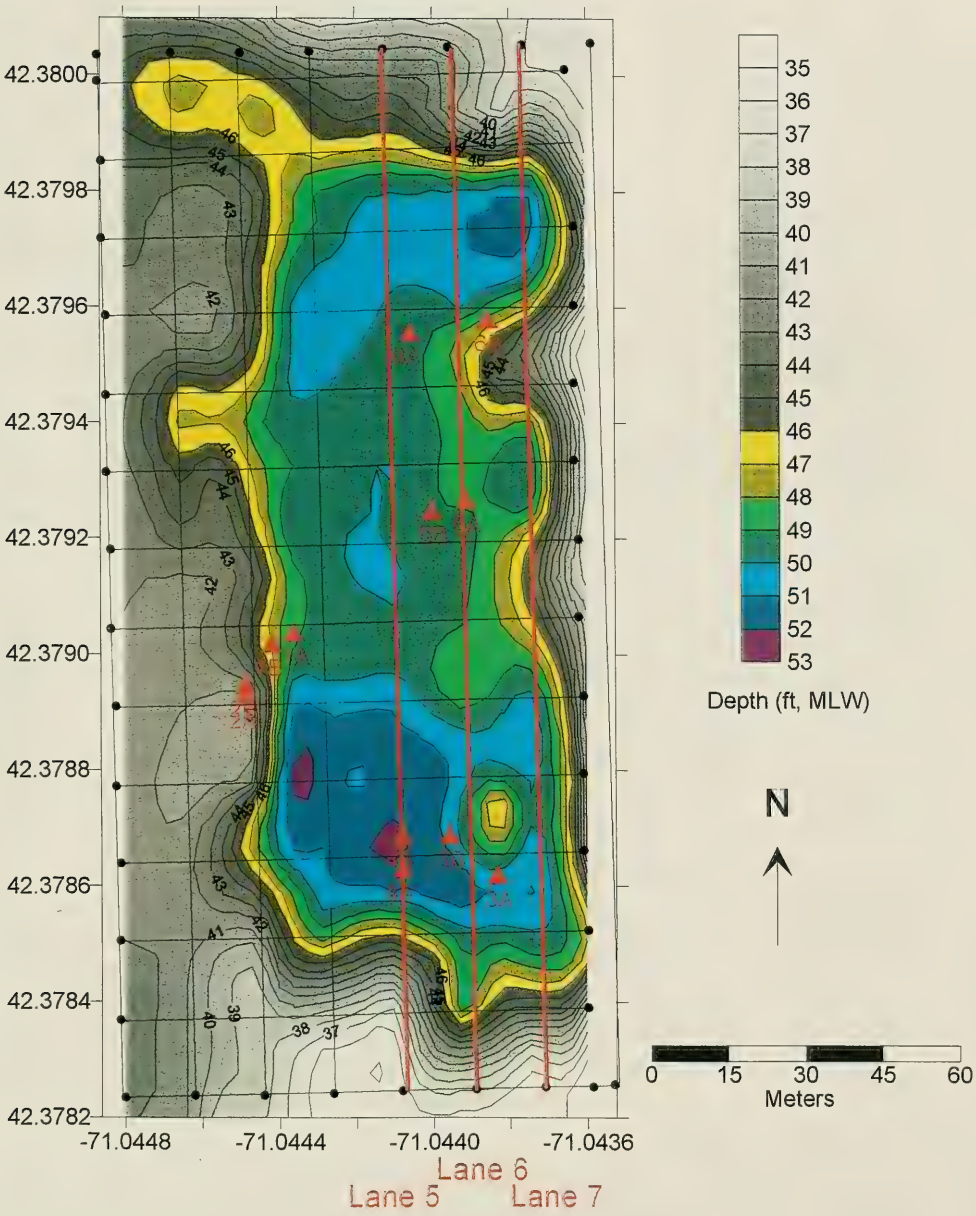
Figure 3-4. Postcap bathymetry of cell collected in October 1997 (NAD83) showing locations of cores and three cross sections.

Two N-S transects of raw depth soundings from the October survey (not gridded data) were extracted from the data to produce cross sections of bathymetry. Lanes 6 (central cell) and 7 (eastern cell) were selected (Figure 3-4). The data were plotted to show the transition from the rough surface associated with the re-dredged sand cap to the smooth surface noted in side-scan sonar data. The results showed that the rough, uneven surface slopes down to the smooth surface, and the transition is approximately ¼ of the distance from the southern end of the cell (Figure 3-5). Note that north and south are reversed between Lanes 6 and 7, and are plotted relative to the direction of the boat transit. The difference in topographic expression was investigated further with vibracore data.

A total of 12 cores at six stations were recovered, with core lengths ranging from 45-241 cm (Table 2-1; Figure 3-4). In all, a total of 14 cores were attempted; two core liners became stuck (Cores CAD-6C, 7A; Figure 3-4). Cores collected from CAD-2A and 2B appeared to be outside of the cell. The recovery of 72-105 cm of apparent dredged material, however, suggested that the cores were actually collected in the cell. One of the CAD-2 cores showed evidence of BBC on the top drive motor, indicating the core was

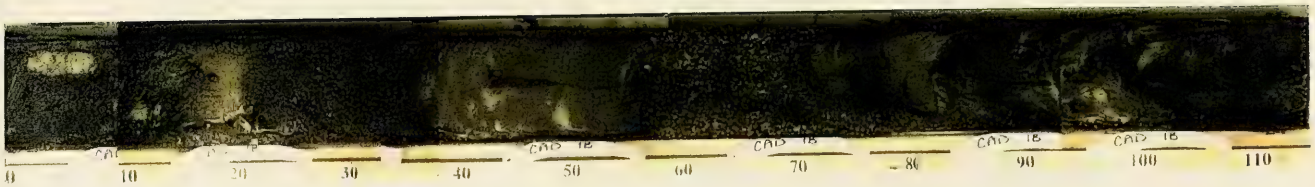
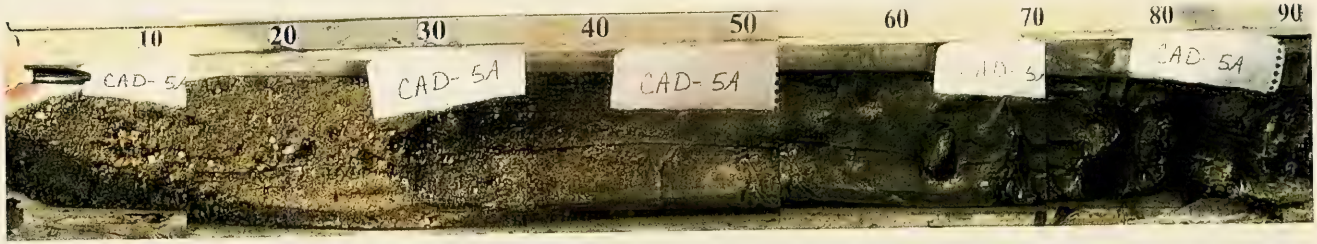
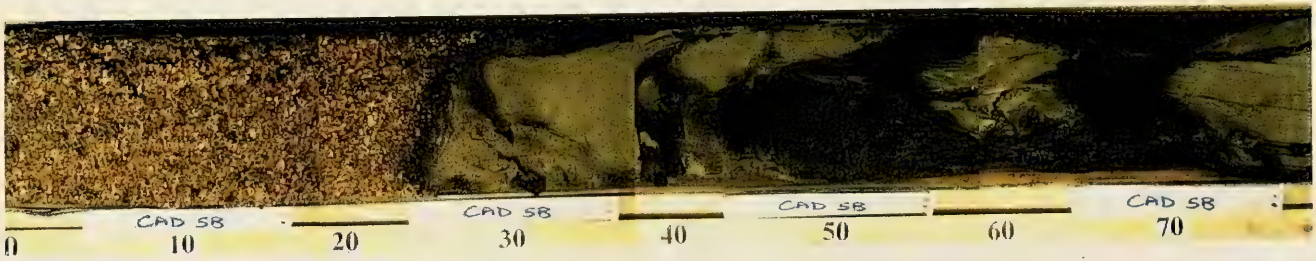
Figure 3-6. Photographs of selected cores, scale in cm.

The dredged material unit was mottled with BBC in many cores, and in one core (CAD-5A), a solid 15 cm interval of BBC was recovered above the dredged material. The presence of BBC in the dredged material was consistent with reports from on-site inspectors. In addition to BBC, discrete sandier intervals were also noted in the dredged material. Data from cores collected prior to capping indicated that the dredged material consisted of up to 30% sand. For classification purposes, if the sand was a minor component of the dredged material, and disseminated throughout an interval, it was classified as dredged material. If the unit was dominated by medium-coarse sand but was infused with black watery silt material, it was classified as mixed.

Cap thicknesses among the four cores where sand cap was clearly recovered at the top of the core (CAD-5A, 5B, 6A, and 6B) ranged from 20-28 cm. In cores CAD-5A and 5B, the boundary between the sand cap and the underlying material was sharp and clearly delineated due to the presence of consolidated clays below the sand (Figure 3-6). The stratigraphy was uncertain at core CAD-6A (45 cm of recovery), because material was lost

The loss of 6C and 7A with evidence of thick sand so close to 6A and 6B indicated a high variability of sand thicknesses. Coring data indicated that mixing of sand and mud of up to 2 out of 3 ft occurred in areas of highly variable sand thickness. This mixing was probably enhanced, and possibly caused, by the force applied to the sand during postcap dredging operations. The consolidation state of the dredged material prior to capping, as shown in Cores CAD-5A and 5B, however, contributed to the presence of a clear sand/dredged material interface. The potential for increasing the consolidation state of the material prior to capping is discussed further in Section 4.0.

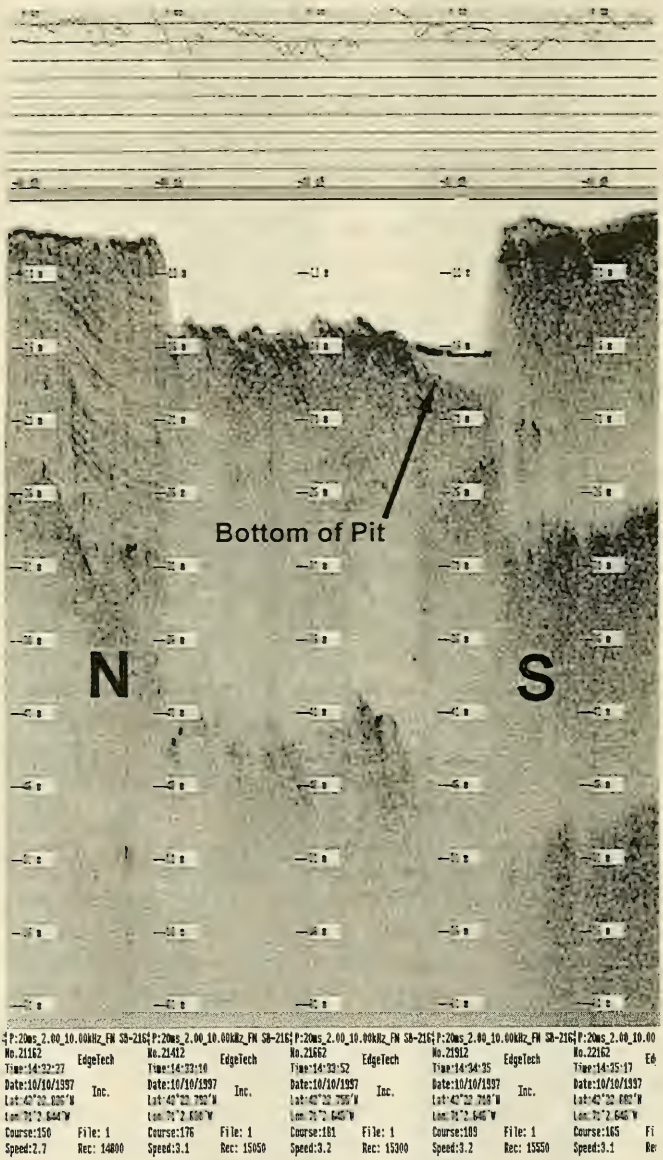
Figure 3-7. Subbottom profile of Lane 5 (see Figure 3-4).

In the area of the cell, much of the subbottom acoustic information reflective of the natural geology of the material was lost, indicating no sound penetration to depths below the dredged and cap material. This result is not surprising, as prior acoustic work over dredged material has indicated that the acoustic signature of dredged material is distinct because of sound loss due to scattering and refraction, indicative of the heterogeneous nature of the deposit (Bokuniewicz et al. 1976; Schock et al. 1992; Murray et al. 1995). Two distinct acoustic regions were consistent with side-scan sonar data. In the southern area of the cell, the top reflector was a strong, smooth reflector indicating a smooth surface with little topography to scatter sound. The high amplitude of the reflector indicated either a harder surface (not borne out by coring data), or a very flat surface. Below this surface reflector, there was a very homogeneous layer as indicated by few internal reflectors, and there is a clear reflector from the base of the cell.

In the central and northern portions of the cell, there was a marked change where the surface became highly irregular as the sound was reflected from the dredge marks shown by side-scan sonar data. Although the surface was very rough and uneven, the amplitude (strength) of the surface reflector was still strong, indicating a relatively hard surface consistent with sand. Below the surface, there was a series of discontinuous internal reflectors indicating a more heterogeneous deposit. Throughout this layer there were u-shaped reflectors that indicated refraction off of irregular deposits. The bottom of the cell was not a continuous reflector, most likely because most or all of the sound was lost in the sand-capped area. This is because at each acoustic boundary where sound was reflected or scattered within the sand deposit itself, less energy was left to continue downward penetration.

The subbottom data indicated that approximately 25% of the cell was uncapped. There was a transition zone between the sand-capped area, and the fine-grained, uncapped area in the south along the N-S cross section (Figure 3-7). Comparing results from cores CAD-1A and 1B near the boundary and the bathymetric transects, it was apparent that there is an interval of transition where sand and mud was interleaved. The reflector along the peak of sand at the southern end of the capped section appeared to dip down towards the south, and was overlain by the mud in that transition. Because the subbottom cross section shown are uncorrected for speed of sound, the transition area between the capped and uncapped portion of the cell should not be interpreted as the actual stratigraphy, as the speed of sound in the sand (and BBC) is faster than in the fine-grained, heterogeneous dredged material. Without digitizing and correcting for speed of sound, the data can still be used to make qualitative conclusions about the interval between the capped and uncapped areas. Because of the weight of the thick sand layer in the central portion of the cell, in combination with the force applied to the central sand cap by the postcap dredging operation, the boundary was most likely characterized by deformed layers of sand and mud.

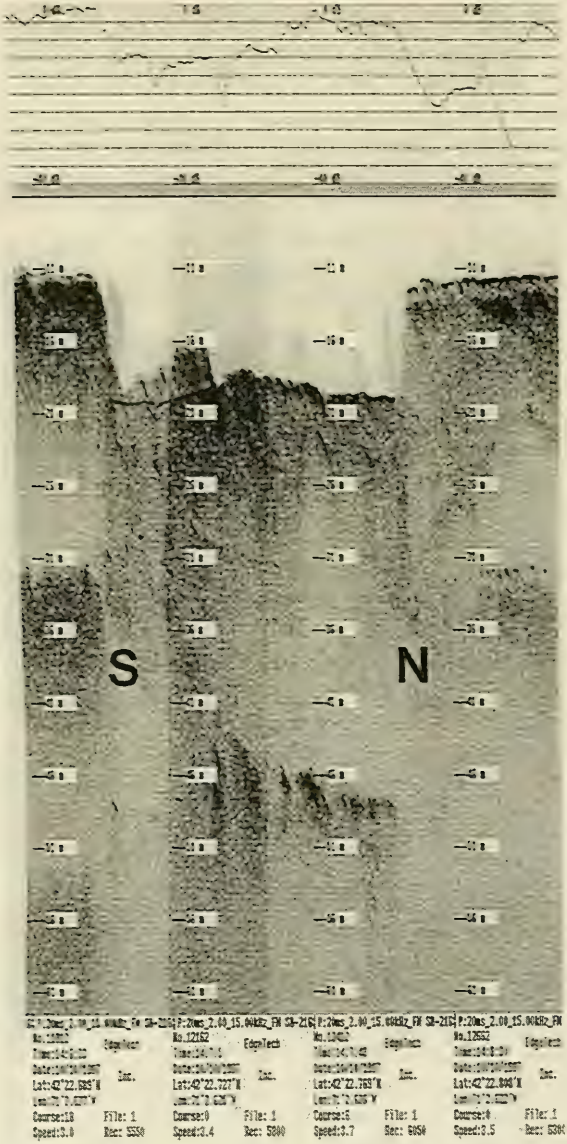
Figure 3-8. Subbottom profile of Lane 7 (see Figure 3-4).

The farthest eastern N-S lane (Figure 3-4), Lane 7, showed two interesting features (Figure 3-8). First, the cell bottom was a relatively continuous reflector below the cap and dredged material. This indicates that the material was more homogeneous, so that sound could penetrate further to the bottom of the cell. In the sand capped area, however, there was still no sand/mud reflector. Results from cores CAD-6B showed a thick mixed boundary between the sand and mud. These data suggested that the method of delineating cap thickness using subbottom will not be effective if there is a mixed zone that is greater than the depth resolution (wavelength) of the system. If there is a consistent sand/dredged material boundary (as in CAD-5A and 5B, Figure 3-6), subbottom will be more effective in determining cap thickness.

Finally, the southern end of Lane 7 showed an apparent mound of material in the southeast corner of the cell overlying the uncapped mud with a clear acoustic reflector in between. This mound was consistent with the topographic peak that showed up in both the bathymetric and side-scan sonar data. This finding has important implications. The subbottom data were consistent with the bathymetric data that suggested material had settled on top of the dredged material after capping was completed. The fact that the material appeared to have settled on top of the uncapped material suggested that the bearing strength of the material had increased from July to October, and was potentially in an advanced state of consolidation that would increase the success of final capping of the material. Further geotechnical testing of the uncapped material by investigators at MIT will be continuing to address the issues of consolidation and bearing strength.

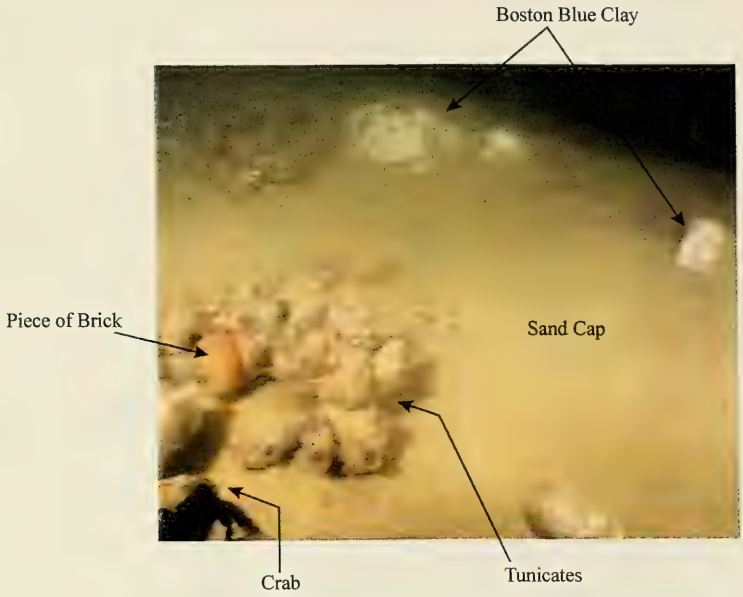
In addition to the surface coverage of sand and mud, the video captured images of *ex situ* material deposited on top of the dredged/cap material deposit, including entrapped debris and blocks of high-reflectance BBC (Figure 3-9). The blocks of BBC probably were remnant from material loosened from the cell walls, similar to the evidence provided by the acoustic data. The presence of debris indicated that material had become entrapped below the ambient current of Boston Harbor and settled on top of the cap. Inferences of the physical environment also could be drawn from the benthic community (tunicates, lobsters, etc.) that inhabited the cell at the time of the video survey. Tunicates, especially, tend to attach to hard bottoms (associated with ship fouling), and are filter feeders. The presence of tunicates on the sand cap indicated that the sand provided sufficiently hard substrate, within a fairly quiescent environment. Finally, video data collected along the cell walls confirmed that the steep walls were scalloped, primarily from the dredging process (Figure 3-10). The BBC walls also had begun to be colonized by a variety of burrowing organisms.

Figure 3-9. Video image of sand cap showing presence of tunicates and other debris.

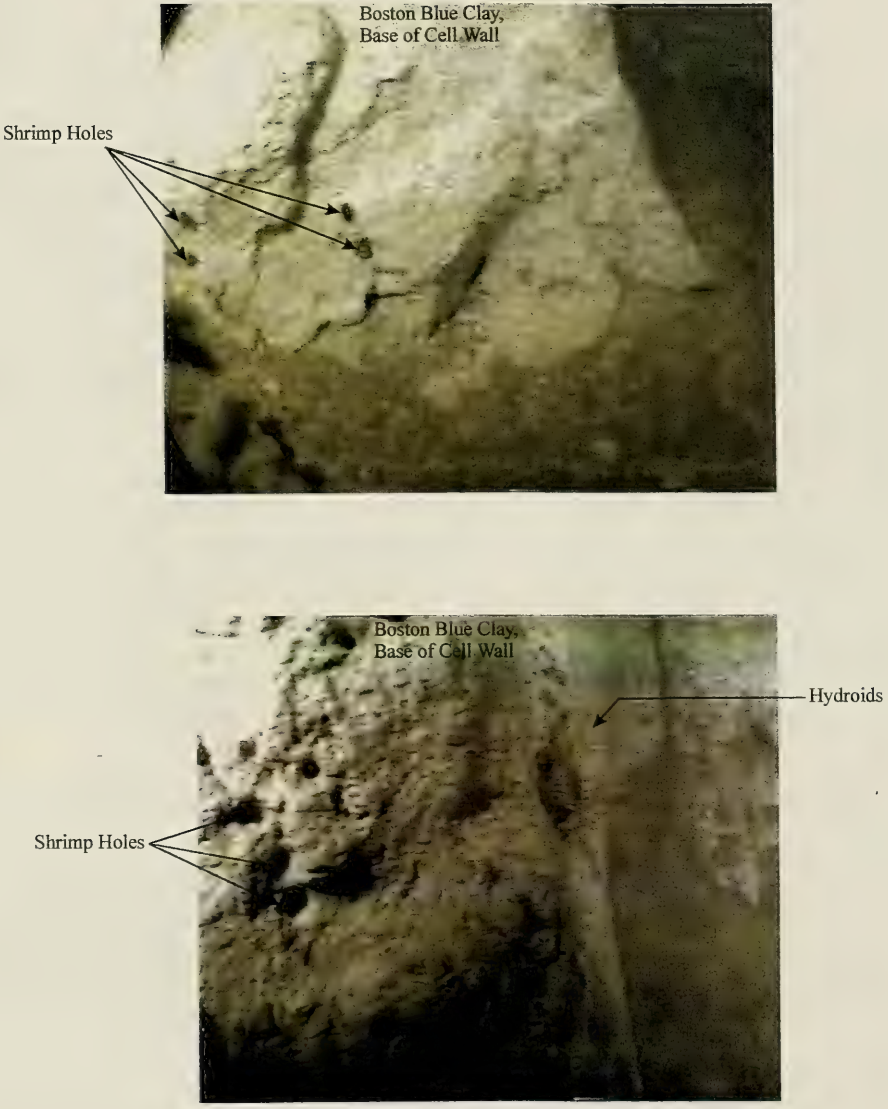
Figure 3-10. Video image of Boston Blue Clay cell wall.
